PLANS FOR
IMPROVEMENT OF NAVIGATION CONDITIONS
IN
CORRAL BAY AND THE VALDIVIA RIVER, CHILE

HYDRAULIC MODEL INVESTIGATION

TECHNICAL MEMORANDUM NO. 2-382

WATERWAYS EXPERIMENT STATION
VICKSBURG, MISSISSIPPI

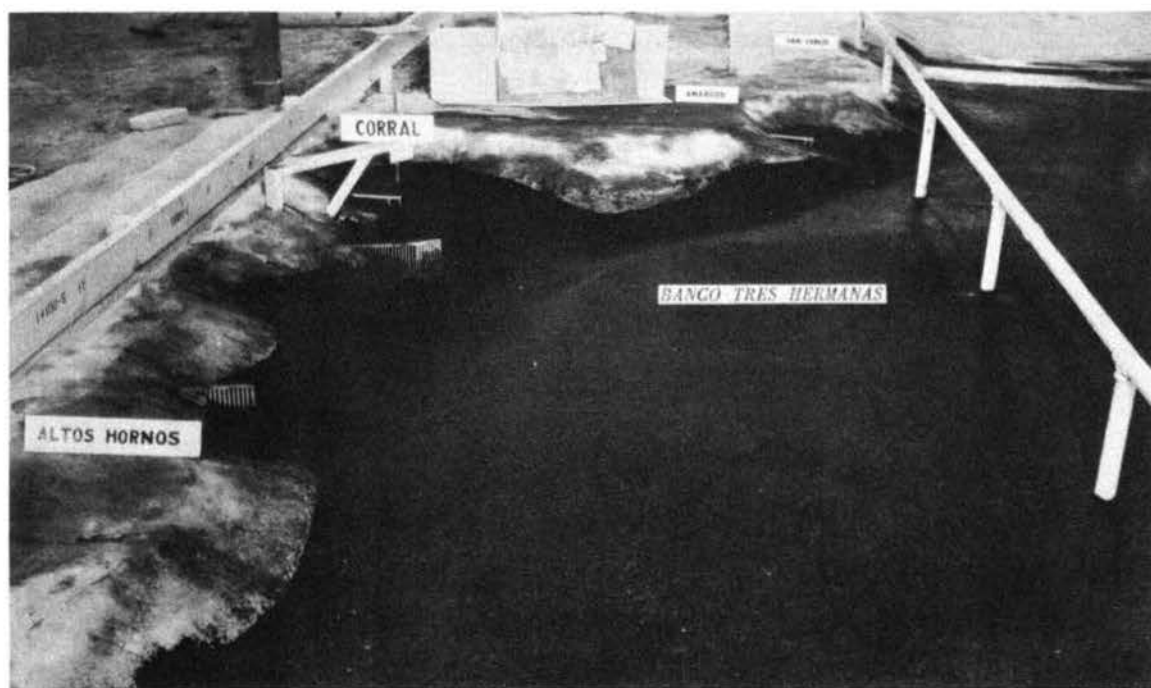
Fig. 3. General view of model looking northwest from San Juan Bay toward port of Corral. Note Three Sisters Shoal in top center

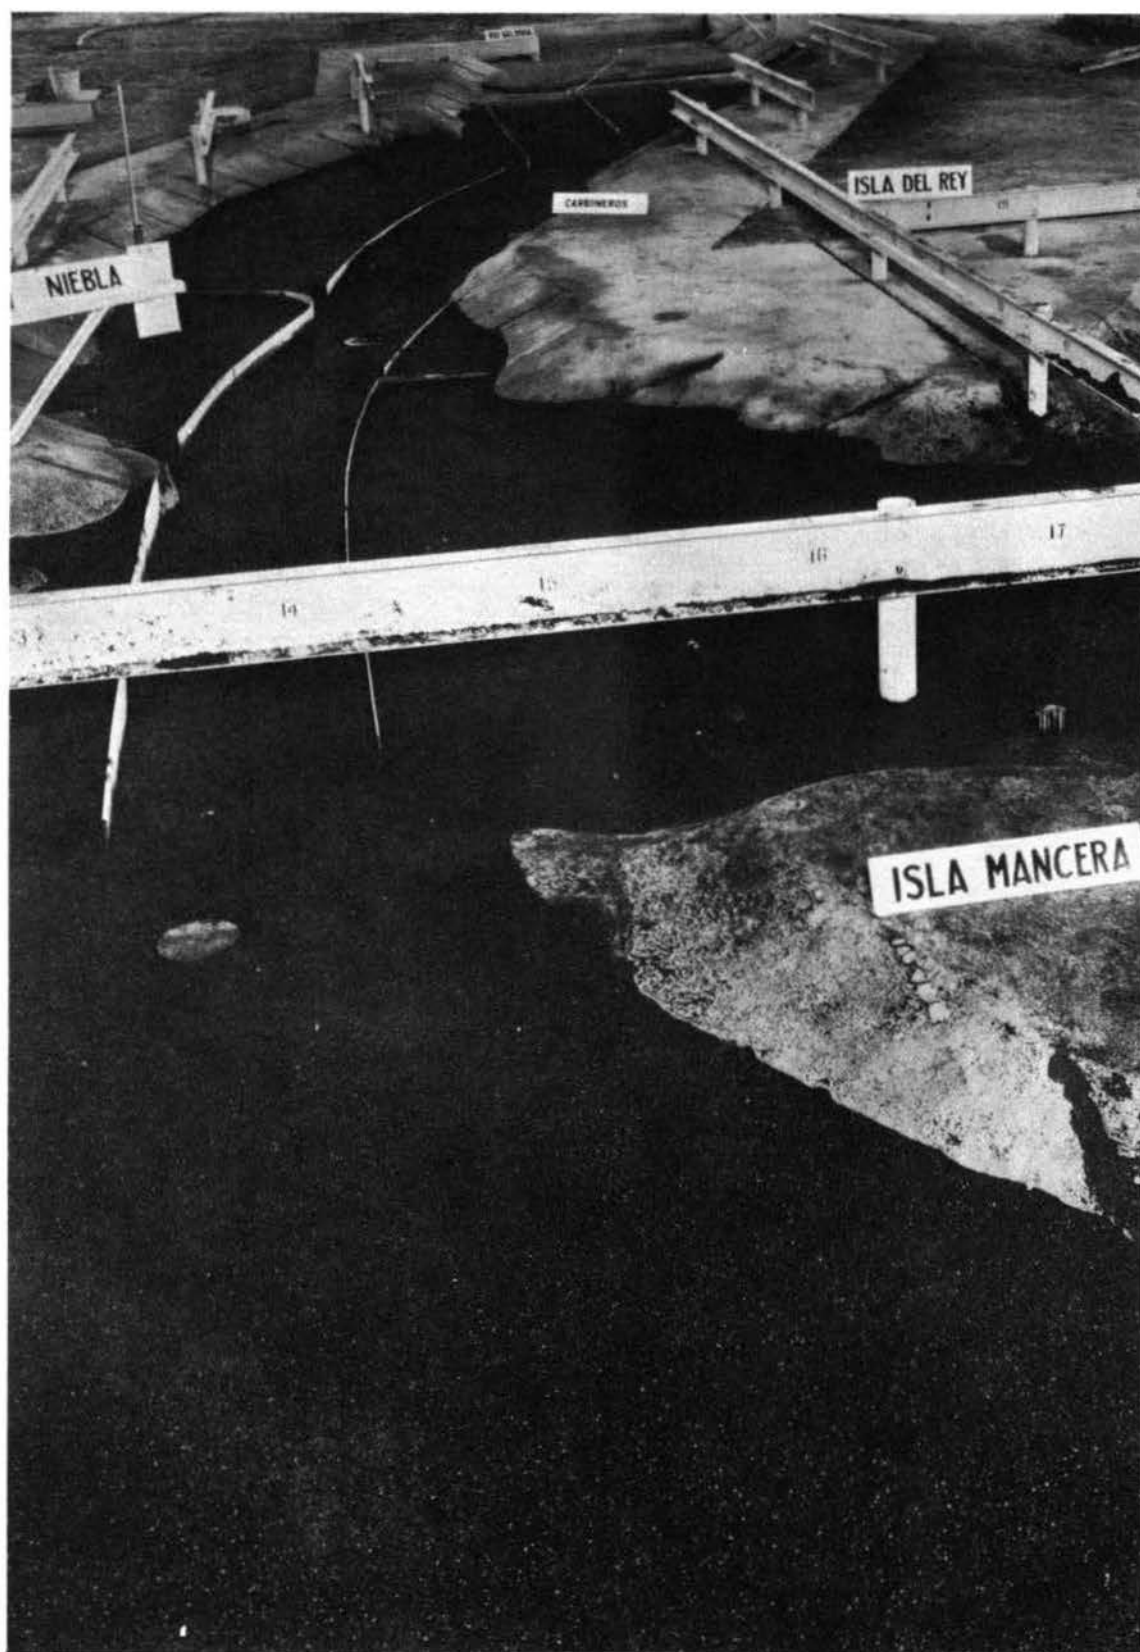
Fig. 4. General view of model looking upstream in Valdivia River from Mal Paso. Note templet and sounding rails

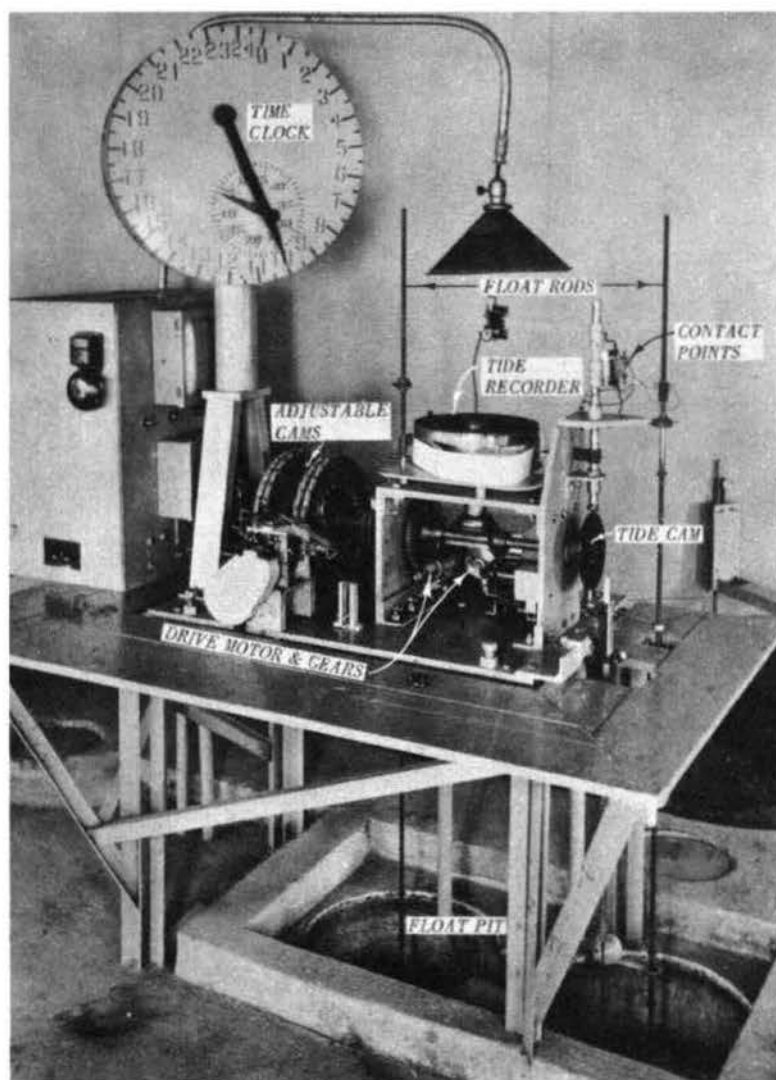
Fig. 5. Master tide generator

of the model, reproduced to scale the prototype mean tide at Los Molinos by maintaining at all times the proper balance between a pumped inflow of water to the model and a gravity outflow from the model as required to simulate all characteristics of the prototype tide being reproduced. The secondary tide generators, located at the extremities of the Tornagaleones and Valdivia Rivers, were adjusted to reproduce accurately the flood and ebb tidal discharges at the locations of the tide generators. With the three tide generators operating in unison, tidal elevations, tidal phases, and tidal discharges and velocities were reproduced accurately throughout the entire model. The master tide generator is shown in fig. 5.

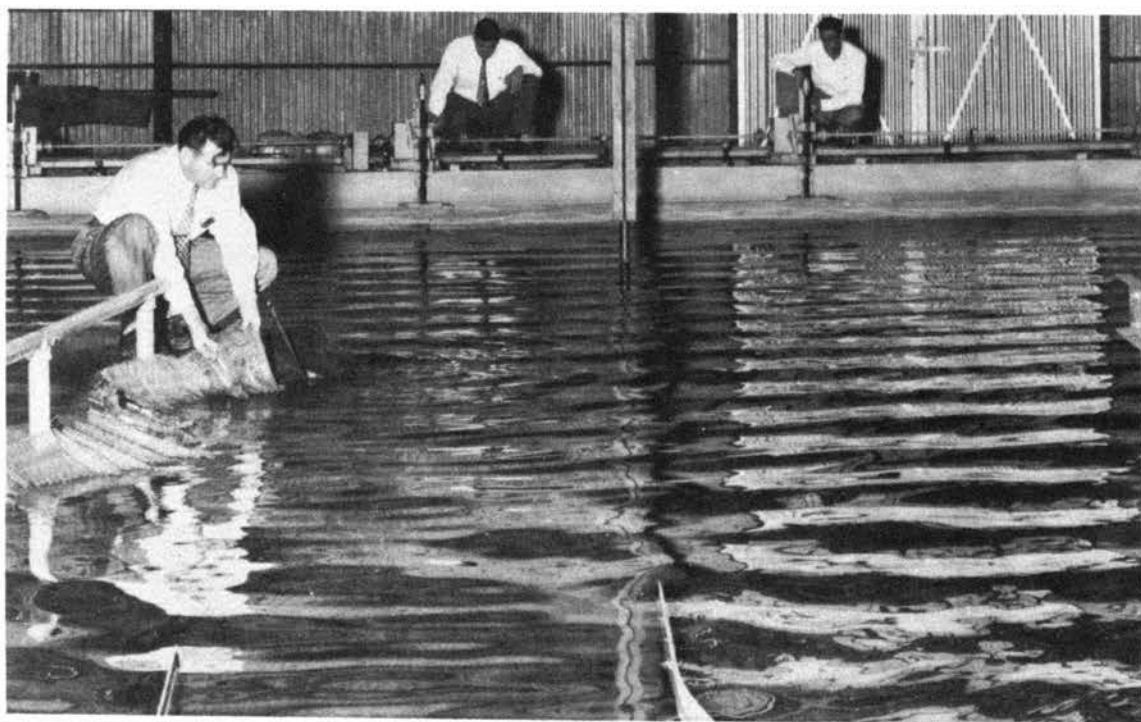
Fig. 6. General view of wave generator in operation

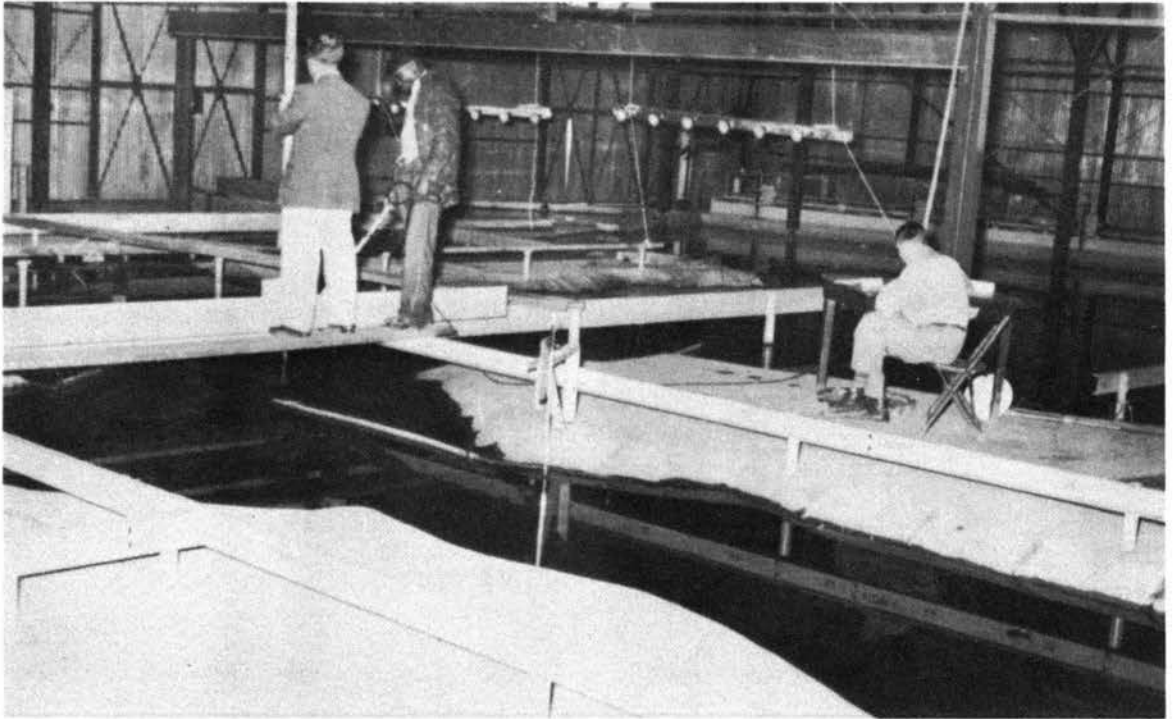
Fig. 8. View of sounding operation making use of horizontally-graduated sounding board mounted on graded rails and vertically-graduated sounding rod

19. The movable-bed section of the model was sounded, or surveyed, at the beginning and end of each test and at frequent intervals throughout the tests. The sounding apparatus, shown in fig. 8, page 14, consisted of a horizontally-graduated sounding board, mounted on the graded templet rails, and a vertically-graduated sounding rod to determine depths throughout the model. The graded templet rails constituted a horizontal control system for location of sounding ranges, as well as a vertical reference plane so that soundings could be referenced to MLLW. The sounding rod was so graduated that depths could be determined to the nearest foot (prototype), and the bottom of the sounding rod was equipped with a hinged metal shoe to prevent penetration of the rod into the coal bed of

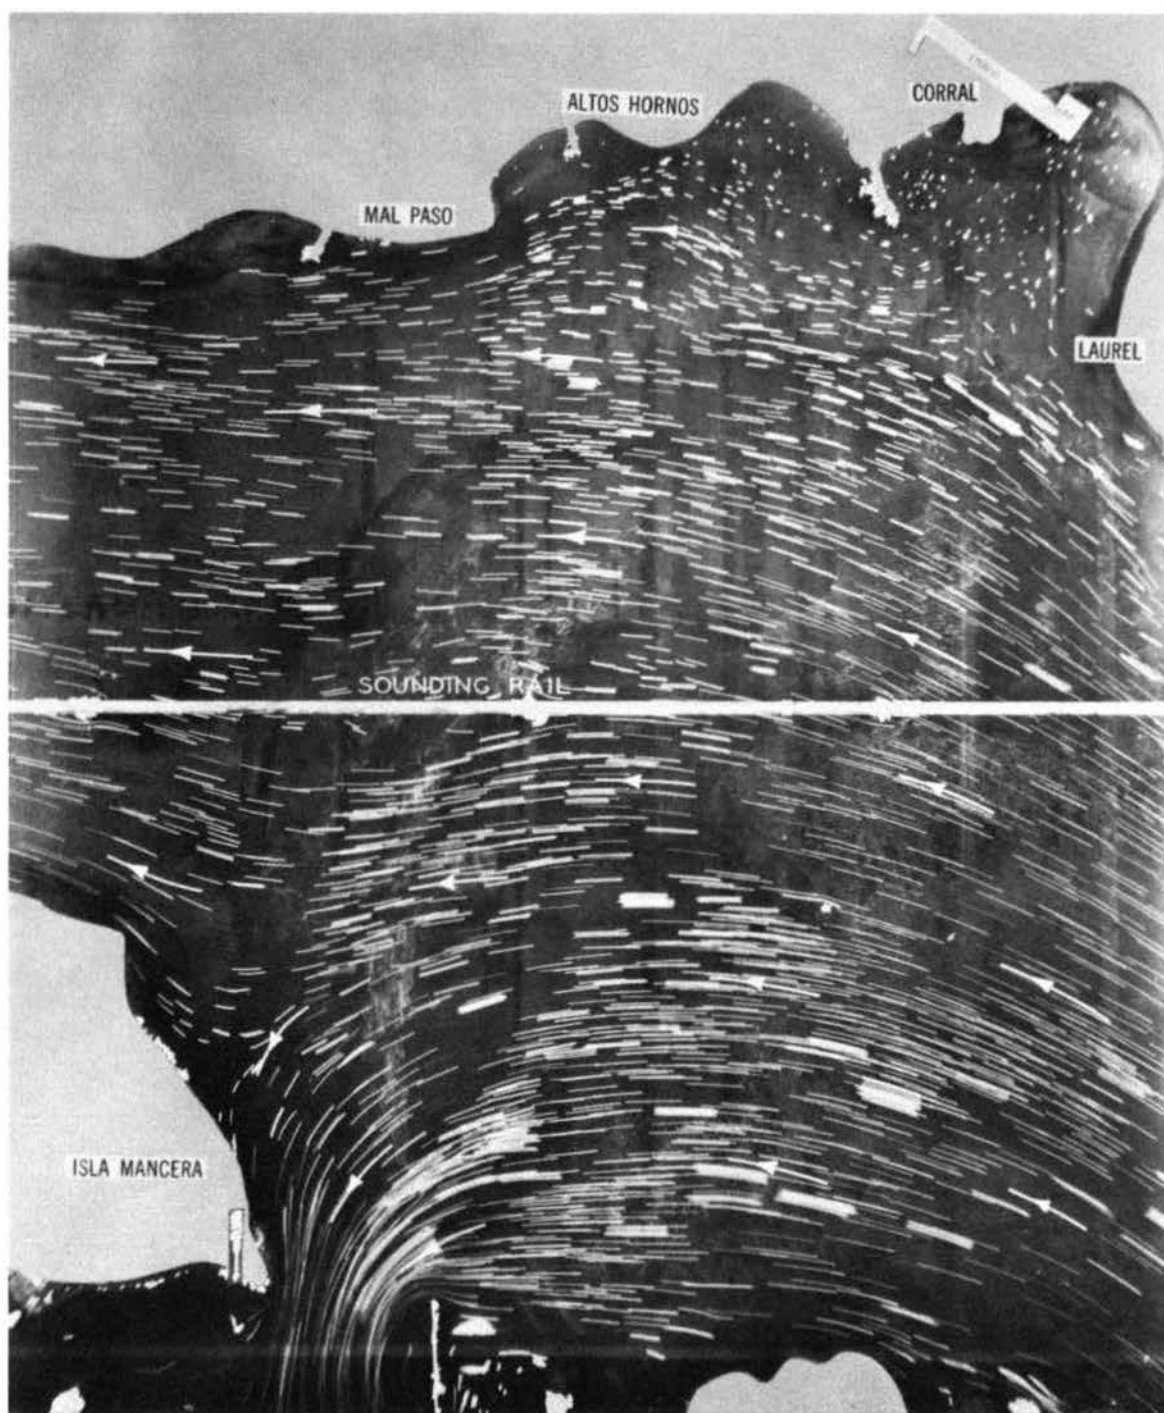
Photograph 1. Strength of flood, base test

43. Surface current directions at strengths of flood and ebb currents in the base test are shown in photographs 1 and 2, respectively. Measurements of tidal elevations and current velocities throughout the model for base test conditions are not presented separately in this report; instead, these data are plotted against similar measurements

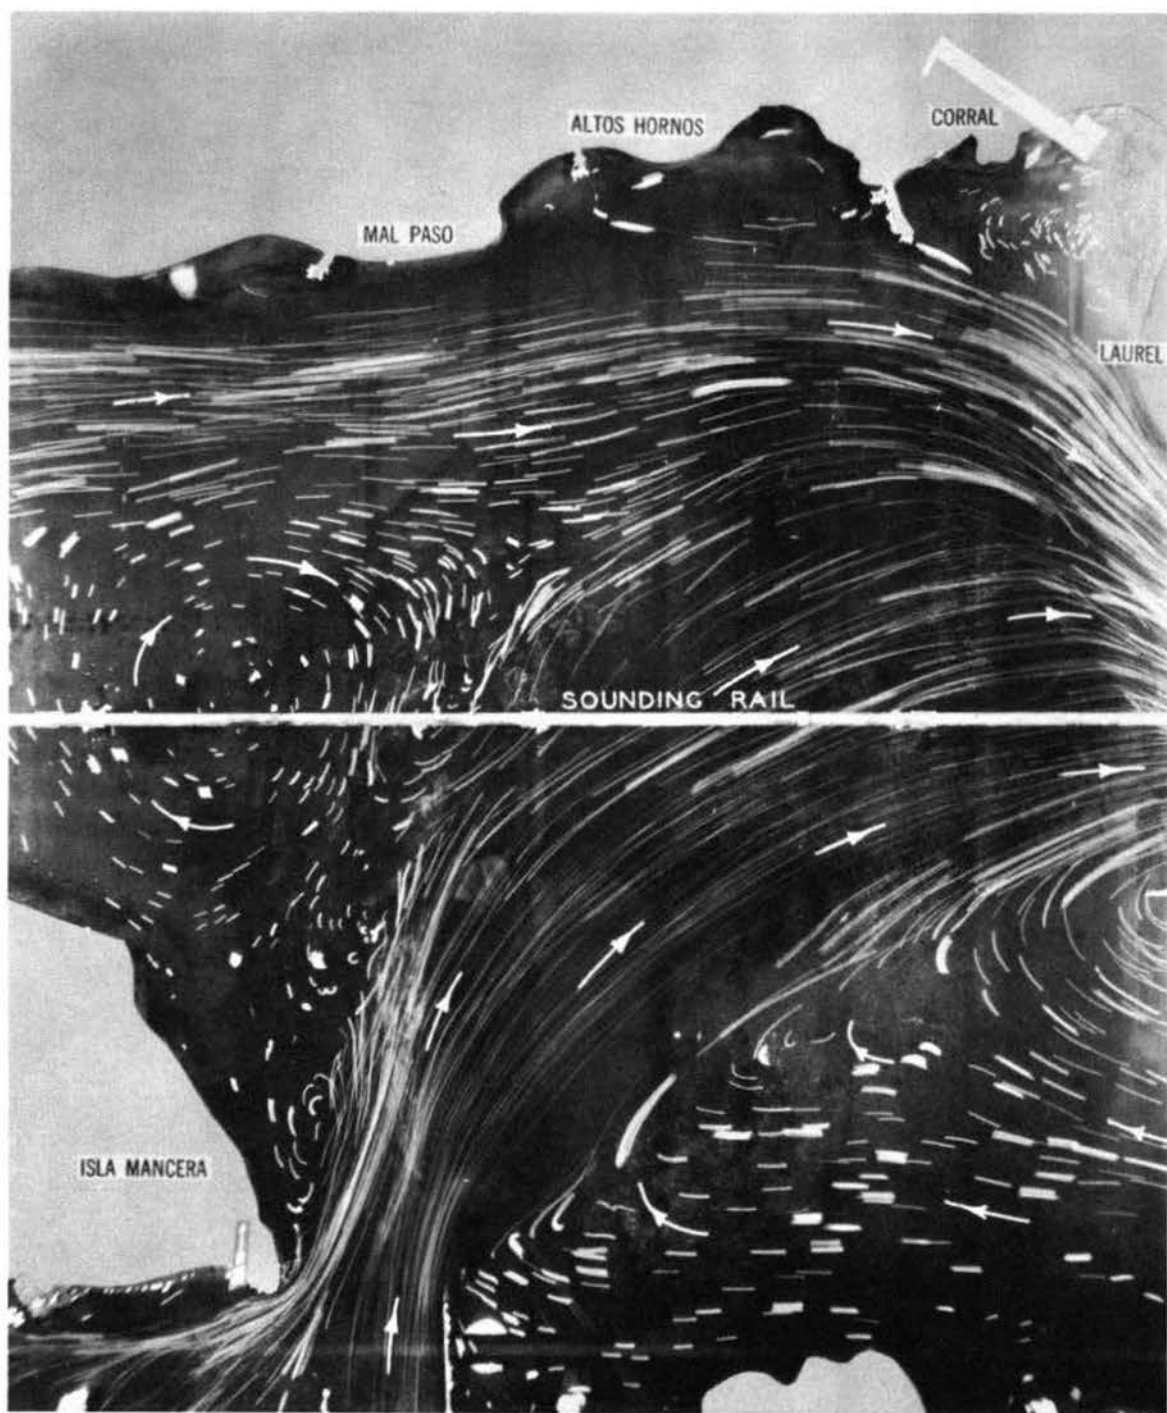
Photograph 2. Strength of ebb, base test

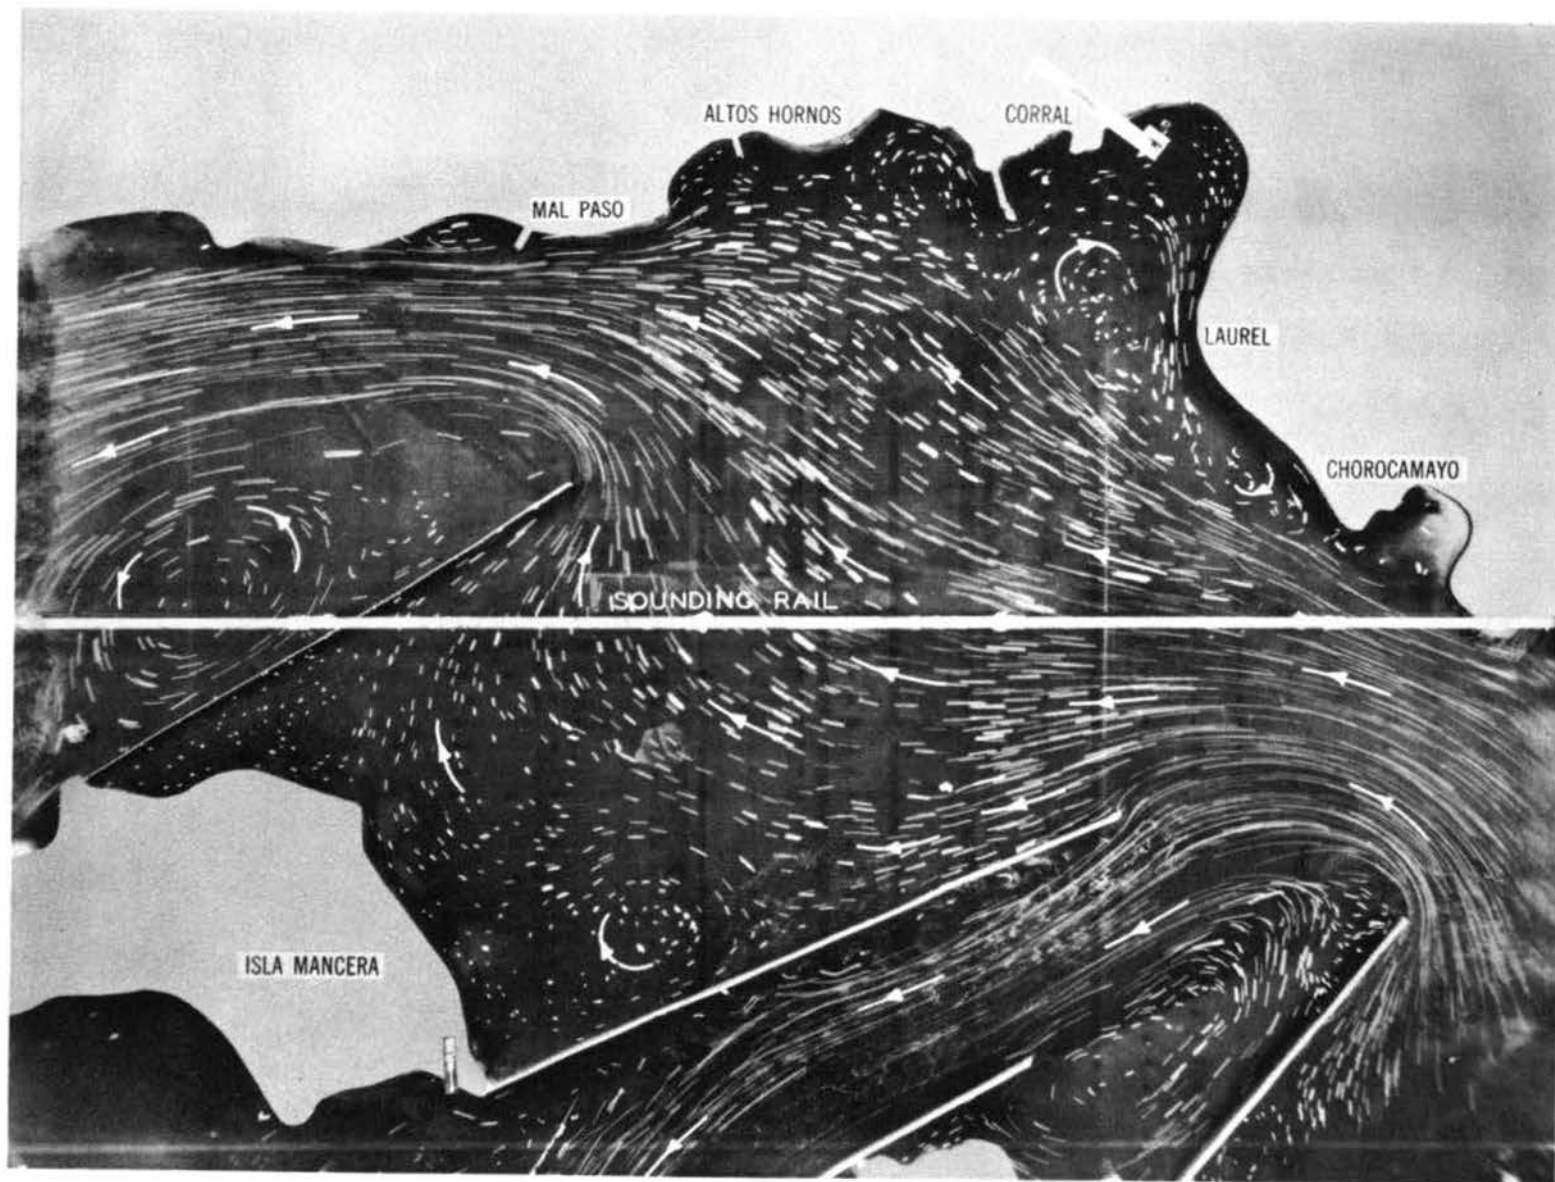
Photograph 3. Strength of flood, plan 1

49. The configurations of the movable-bed at the end of the test of plan 1 are shown on plate 12, and the scour and fill that occurred during the 12-year test period are shown on plate 13. Photographs 3 and 4 show surface current directions throughout the problem area at strengths of flood and ebb currents, respectively, at the end of the test of plan 1. The effects of the plan on tidal elevations throughout the problem area are shown on plates 14 and 15, and its effects on current velocities are shown on plates 16 and 17.

53. Examination of the current-direction patterns for plan 1 (photographs 3 and 4) shows that, with minor exceptions, current directions were fairly uniform throughout the problem area. The current pattern at strength of flood indicated irregularities in flow alignment and the existence of eddies between the seaward ends of structures M and N, in the vicinity of the port of Corral, and between structure R and Mal Paso. Current directions at strength of ebb were as uniform as could be expected except possibly in the vicinity of Three Sisters Shoal where the current divided and passed around both sides of the crest of the shoal.

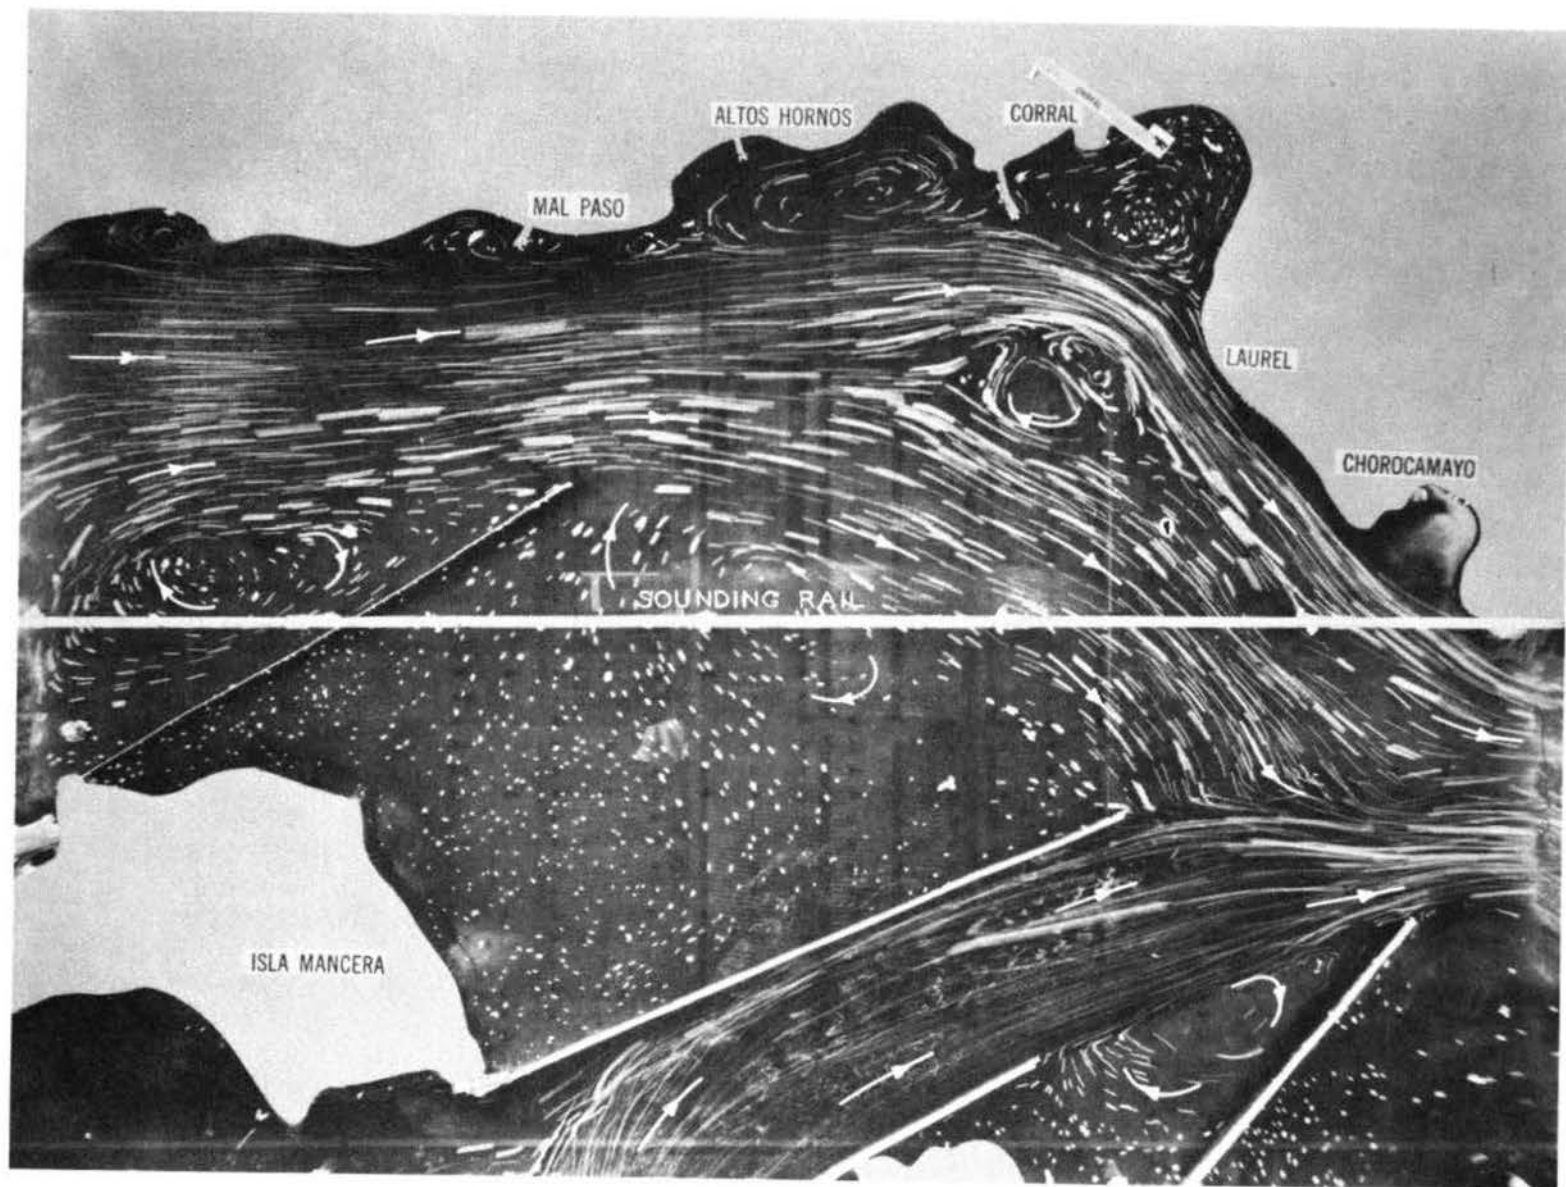
Photograph 4. Strength of ebb, plan 1

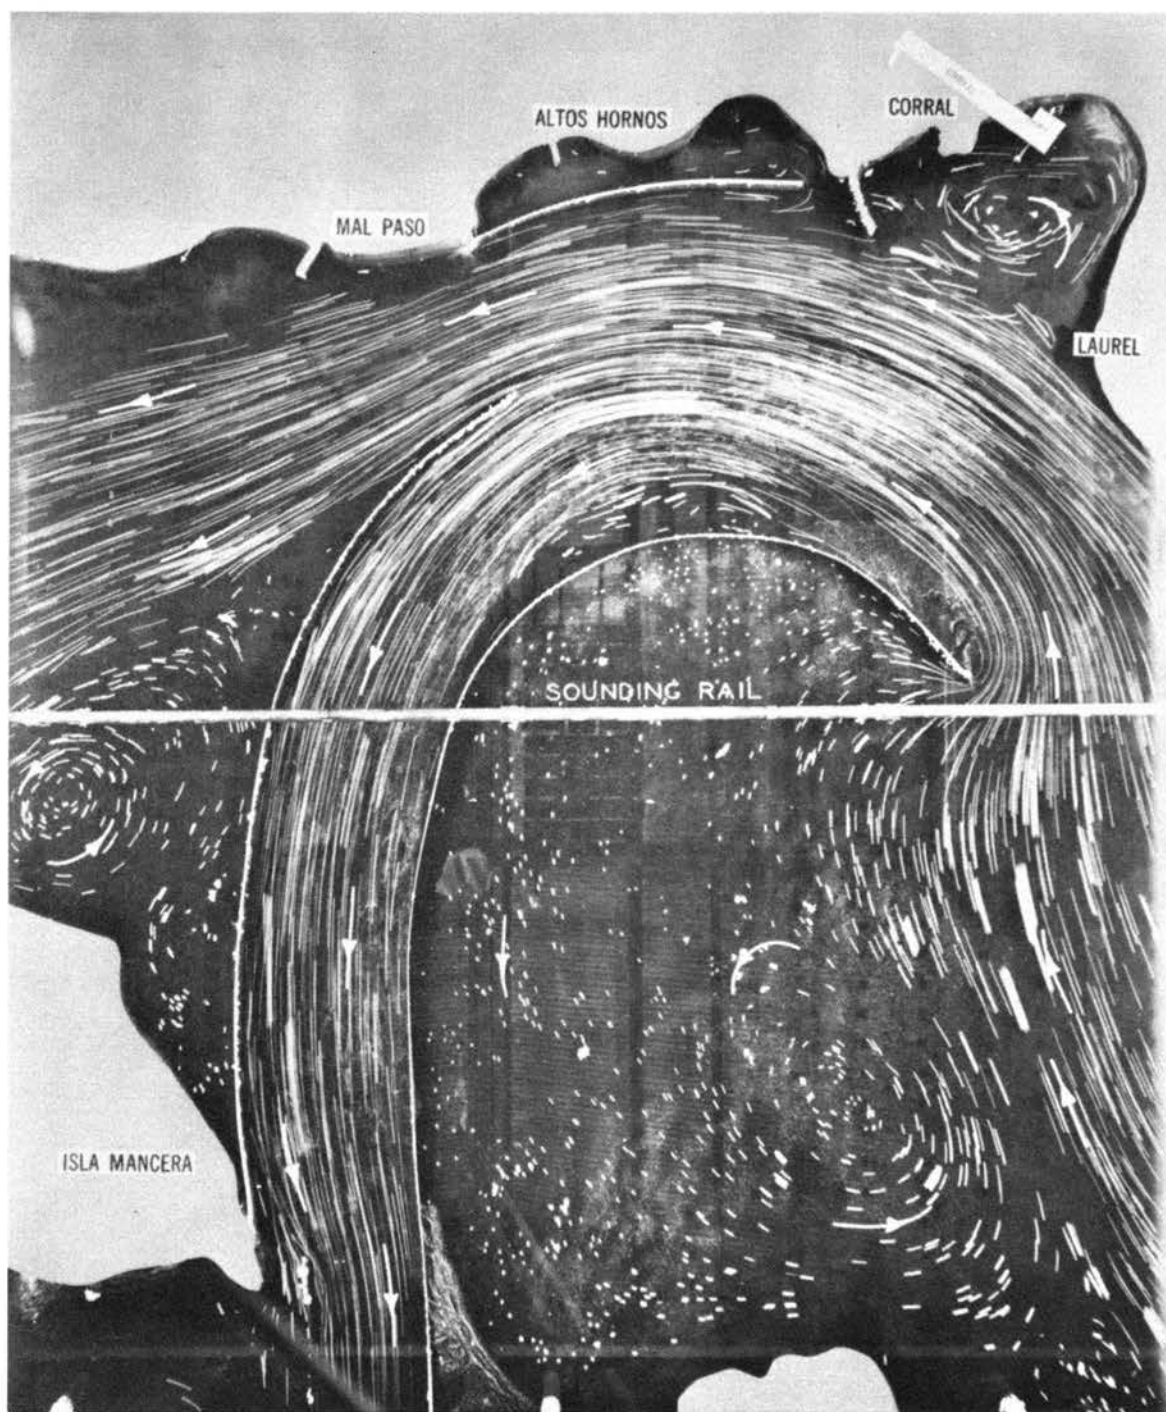
Photograph 5. Strength of flood, plan 2

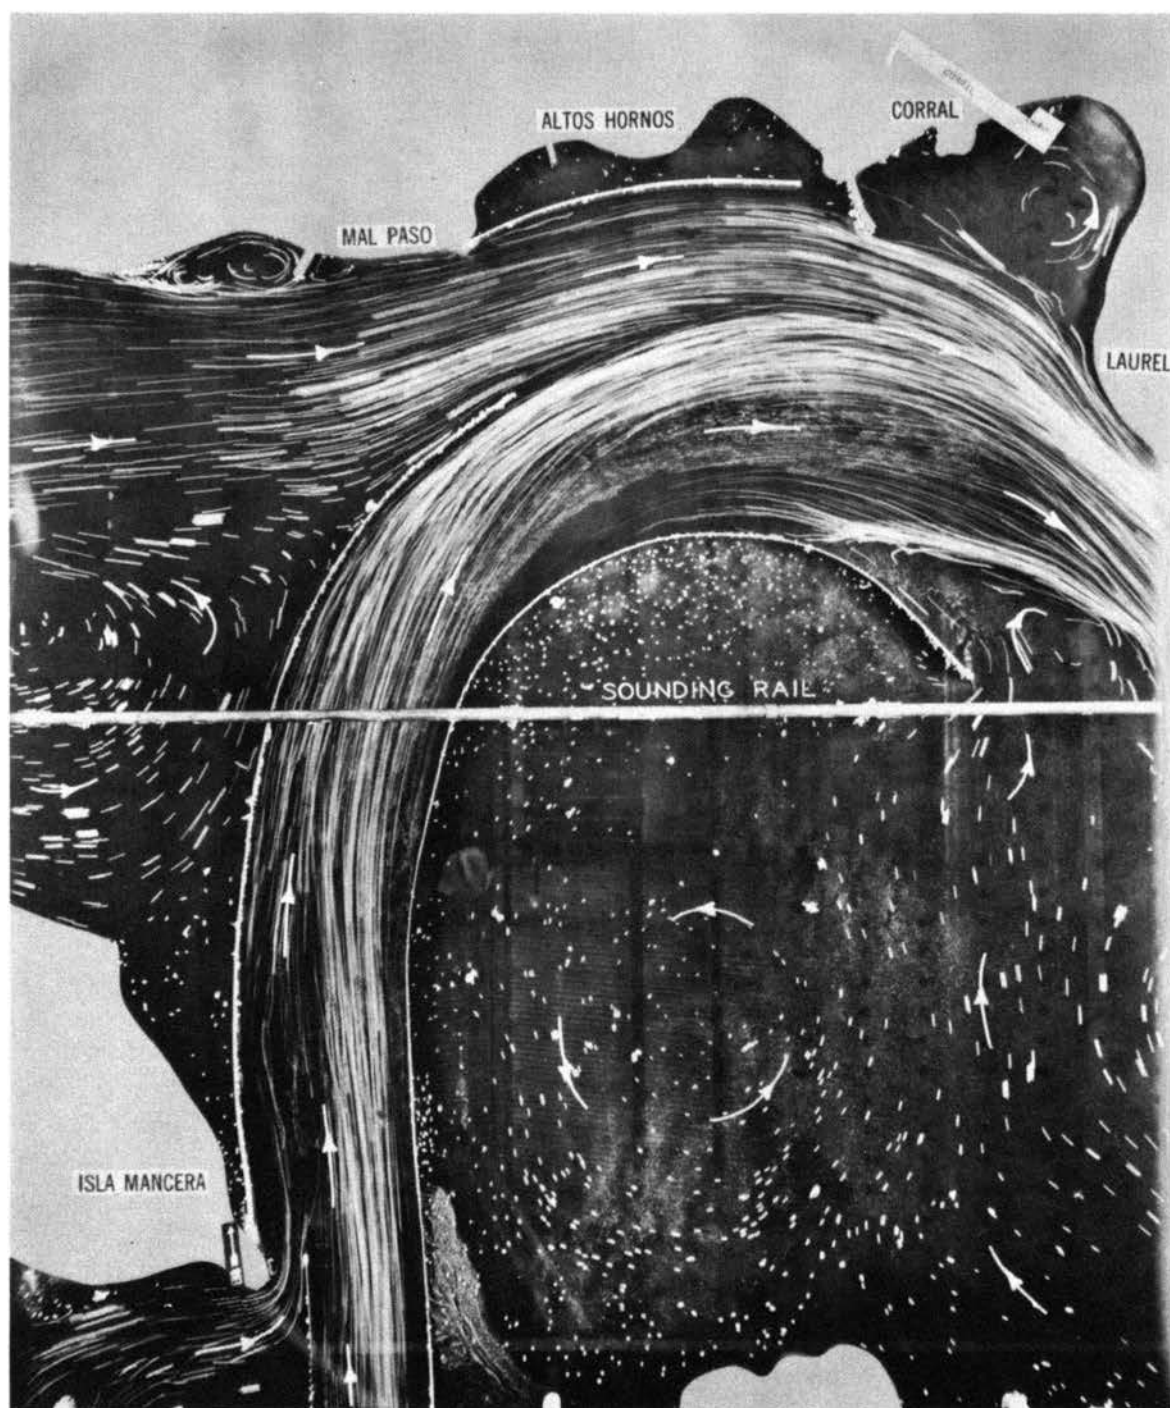
Photograph 6. Strength of ebb, plan 2

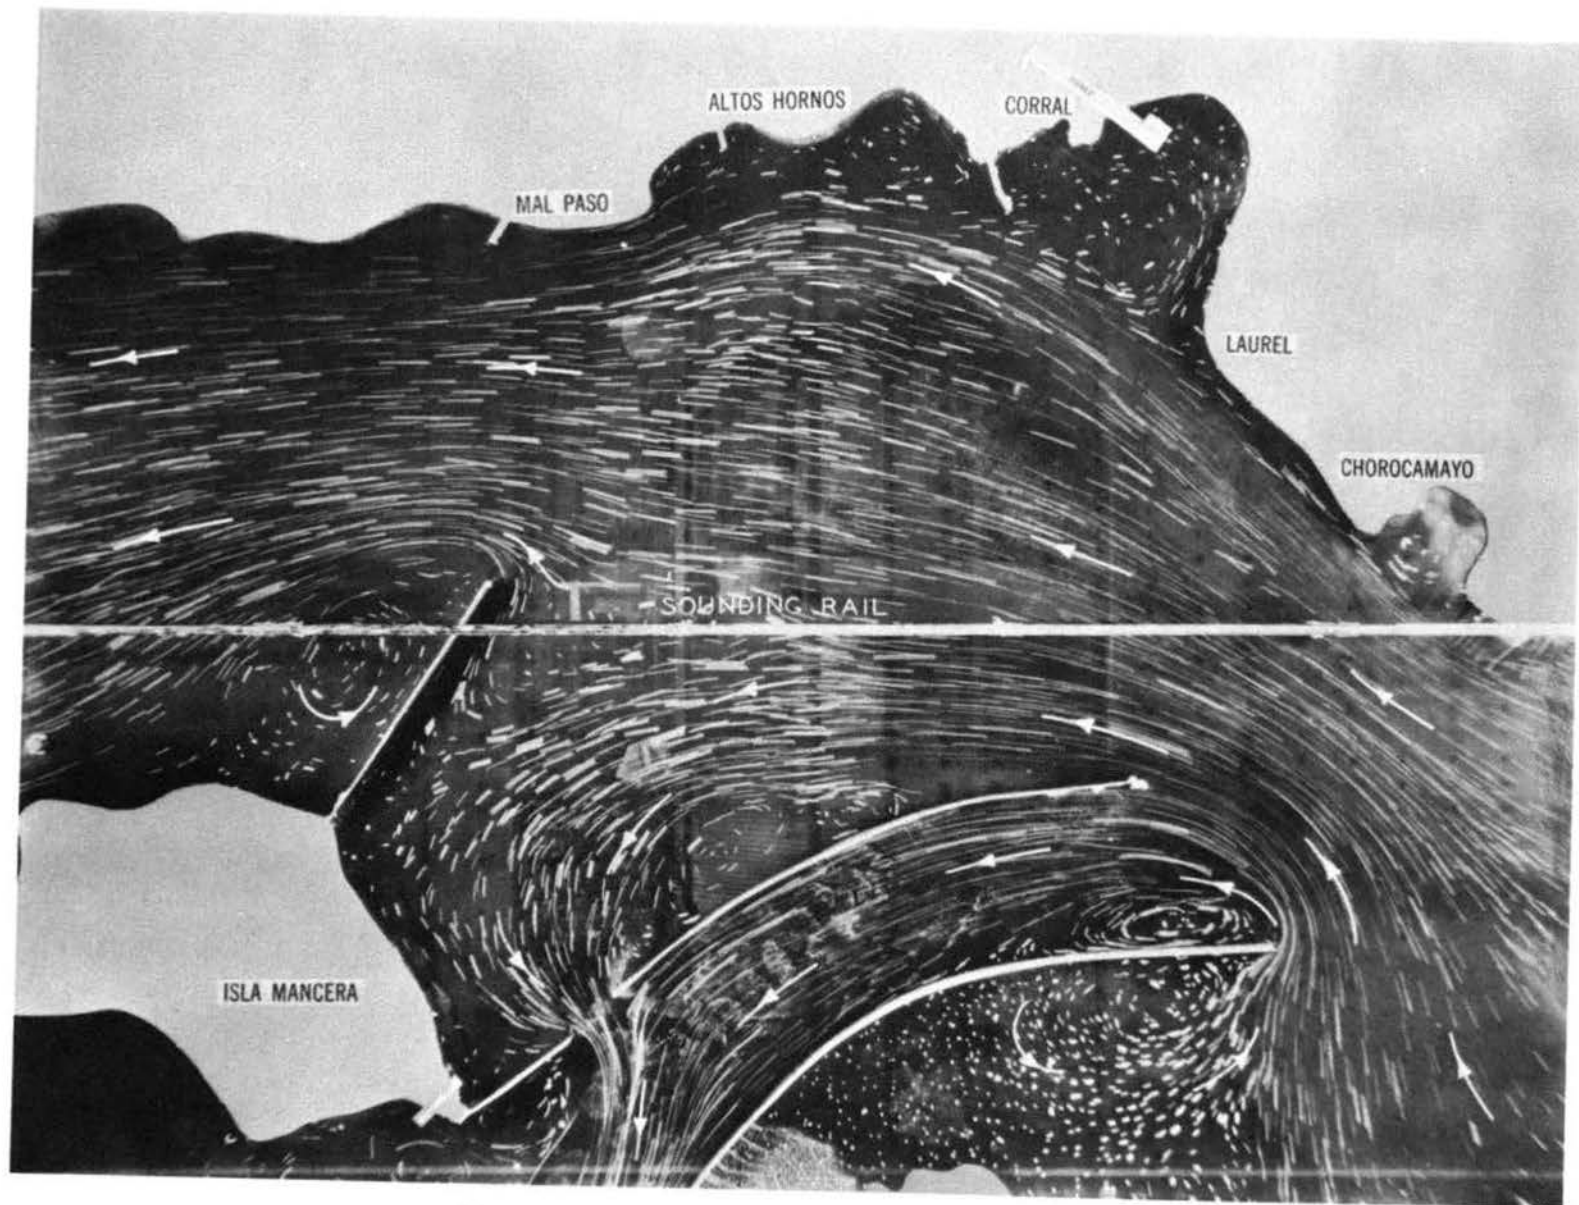
Photograph 7. Strength of flood, plan 3

effects of plan 3 on tidal heights throughout the problem area, while plates 30 and 31 show the effects of the plan on current velocities. Photographs 7 and 8 show surface current directions for plan 3 at strength of flood and ebb, respectively.

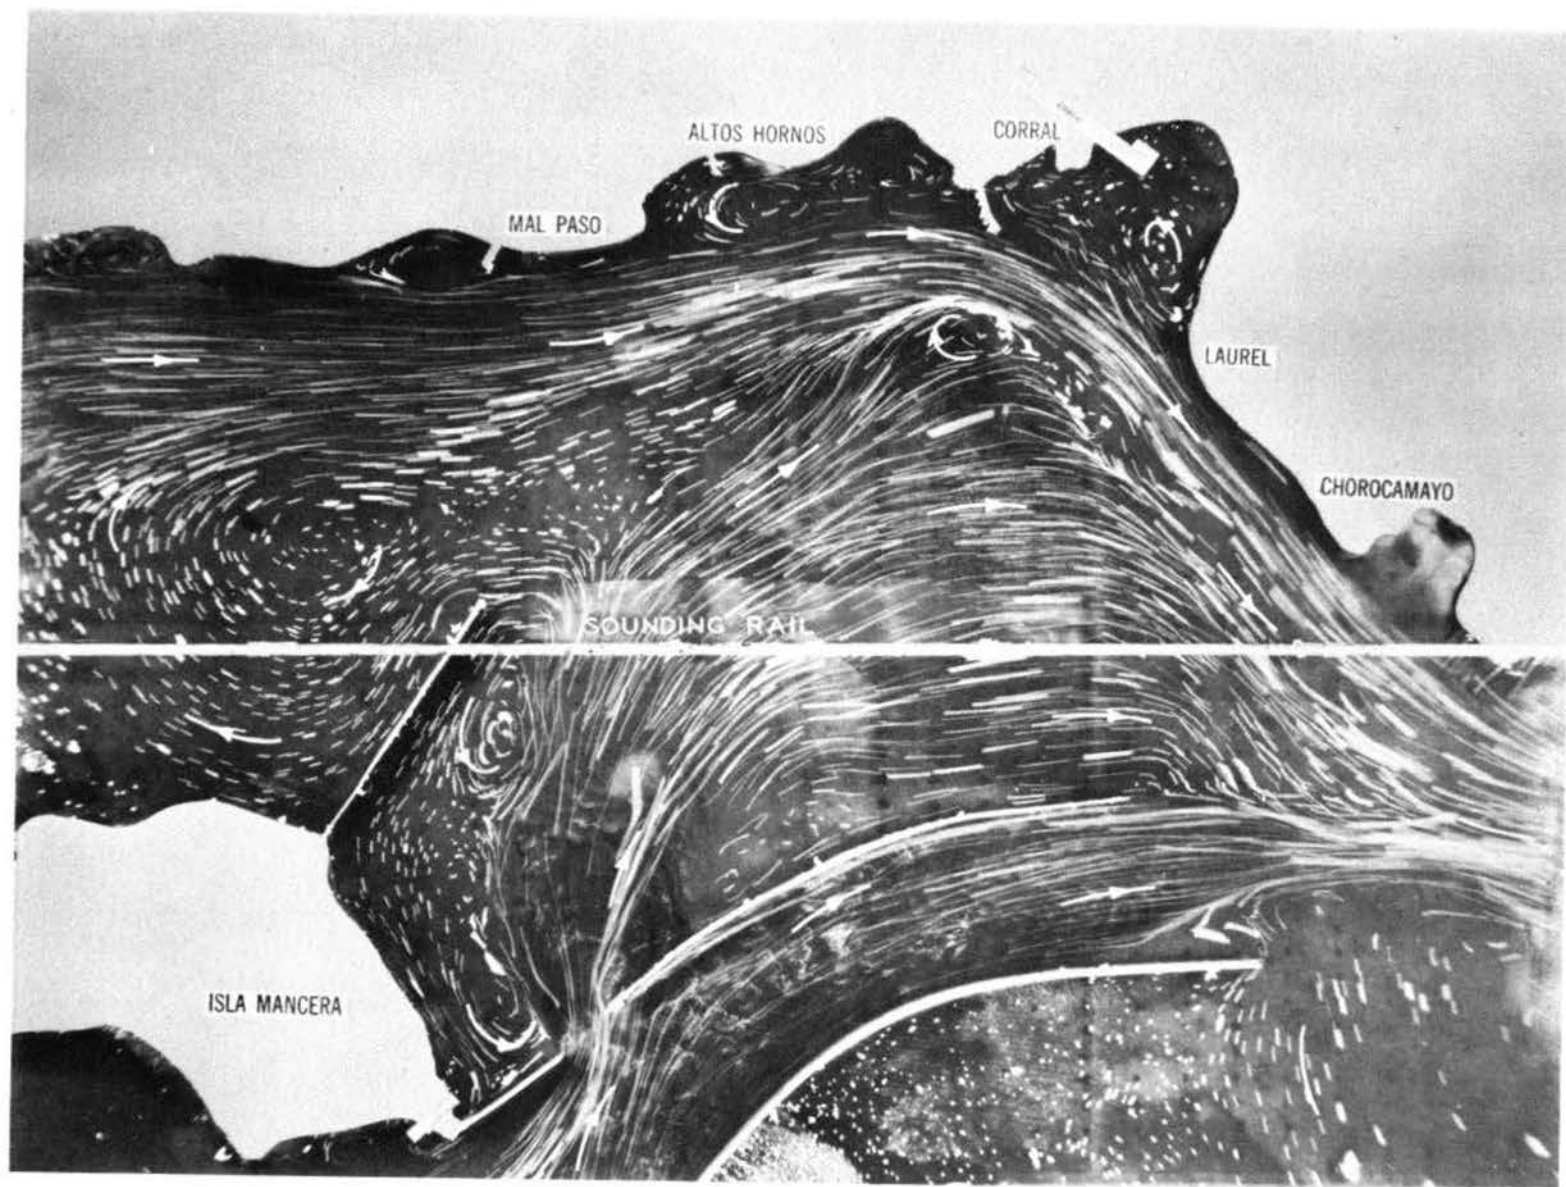
Photograph 8. Strength of ebb, plan 3

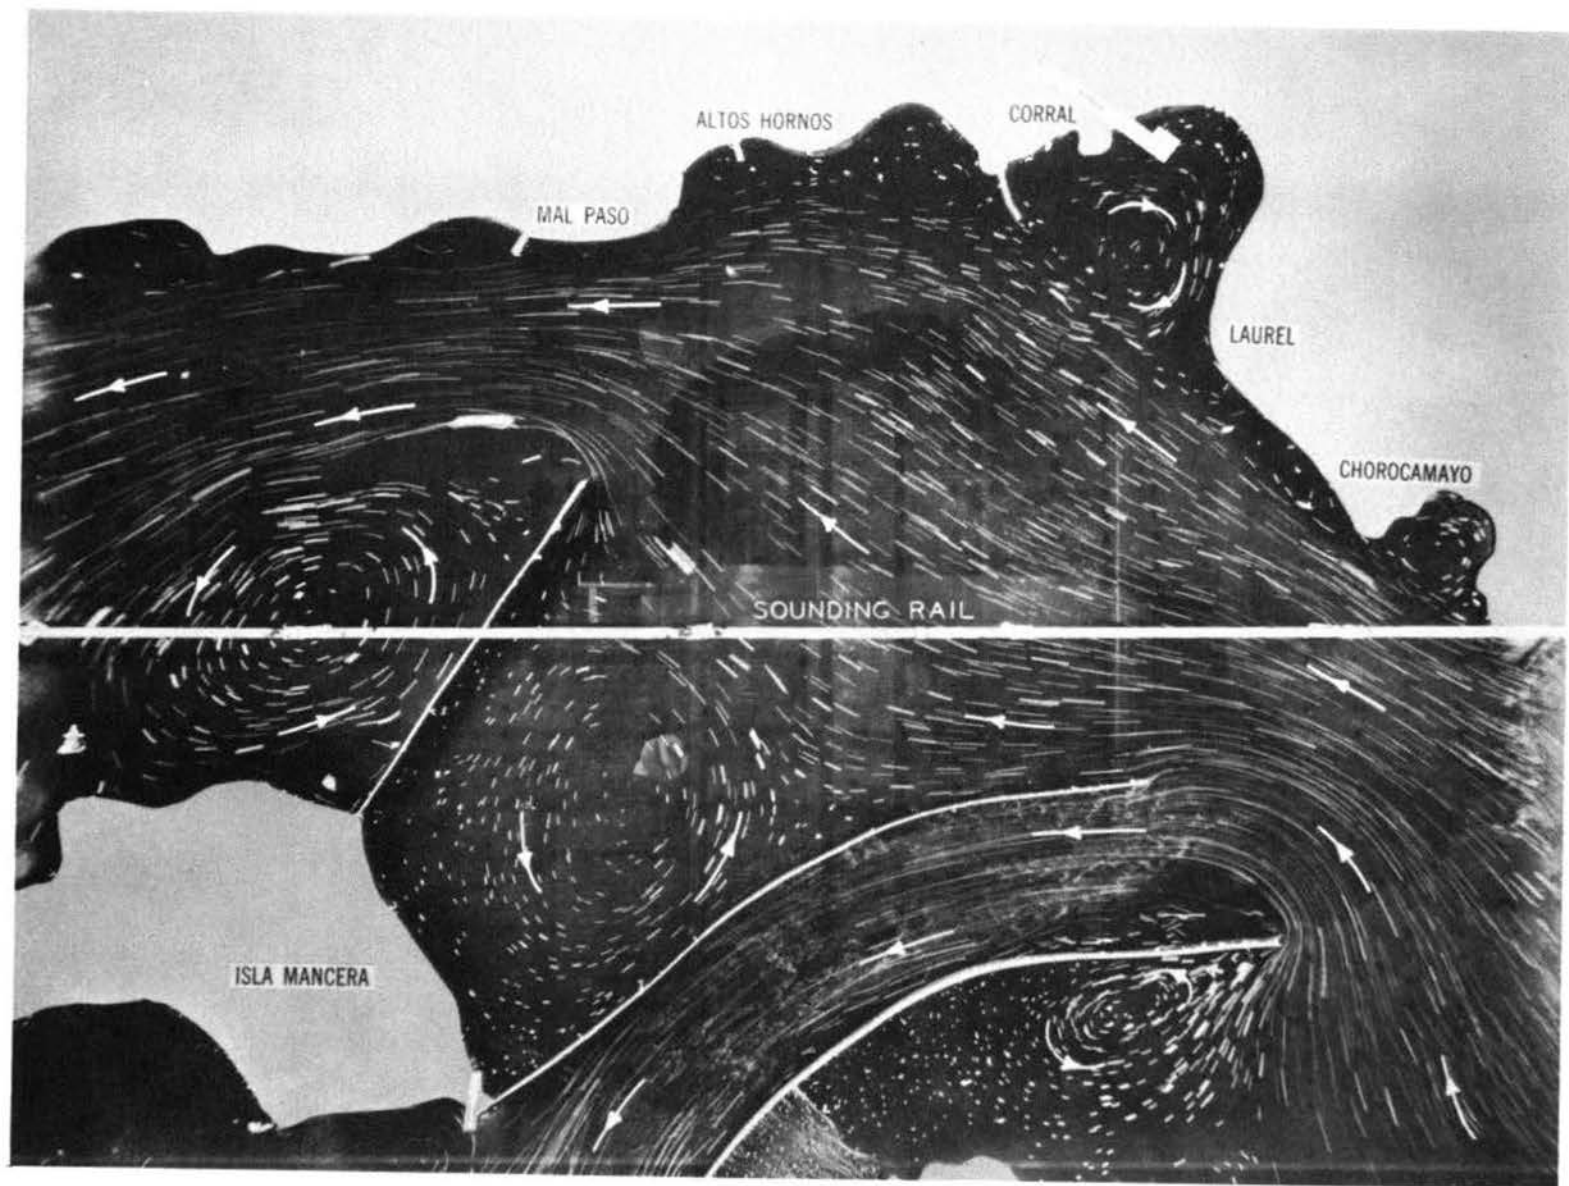
Photograph 9. Strength of flood, plan 4
